BANK CAVING INVESTIGATIONS
MORVILLE REVETMENT, MISSISSIPPI RIVER

TECHNICAL MEMORANDUM NO. 3-318

BY
WATERWAYS EXPERIMENT STATION
VICKSBURG, MISSISSIPPI

SEPTEMBER 1950

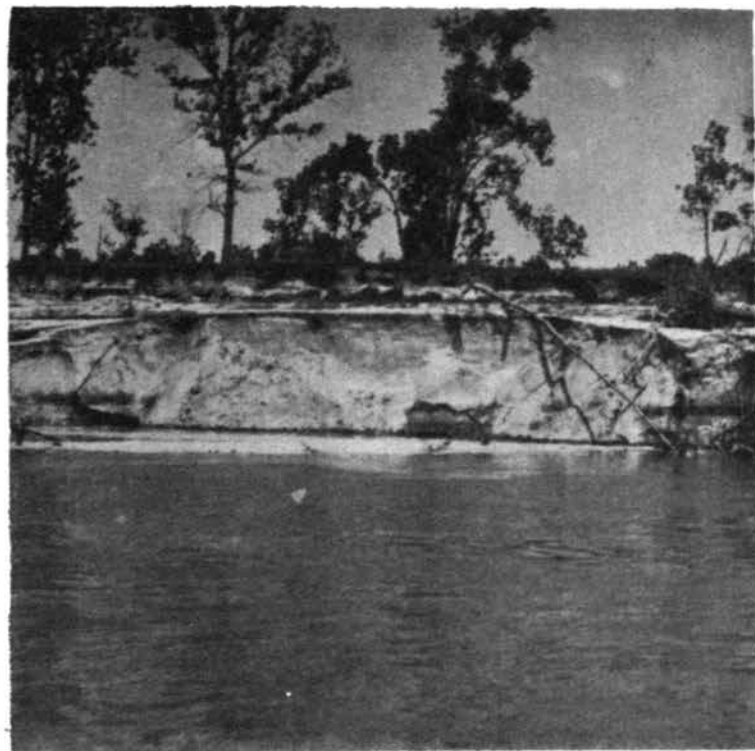
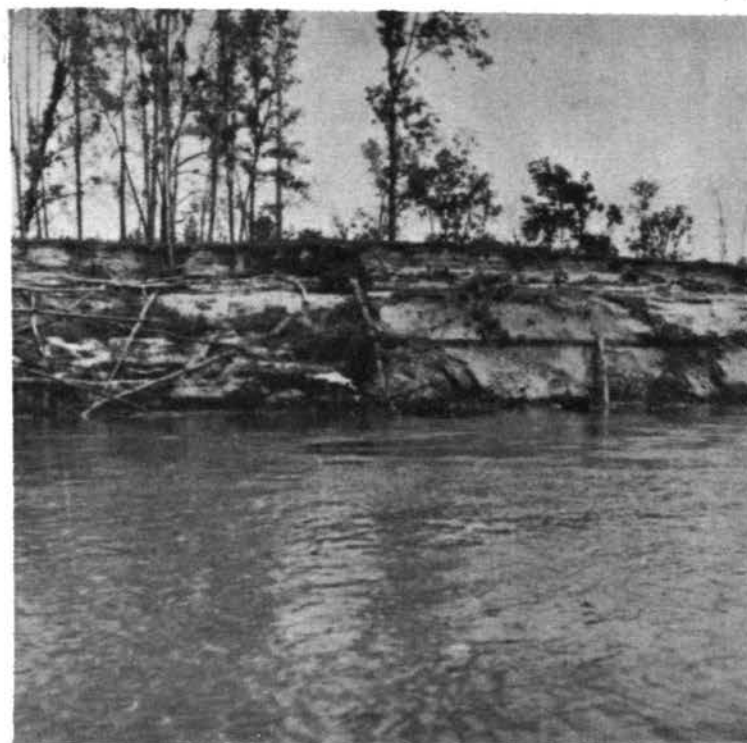
BANK CONDITIONS ON NATCHEZ ISLAND
UPSTREAM POINT 18 JUNE 1949

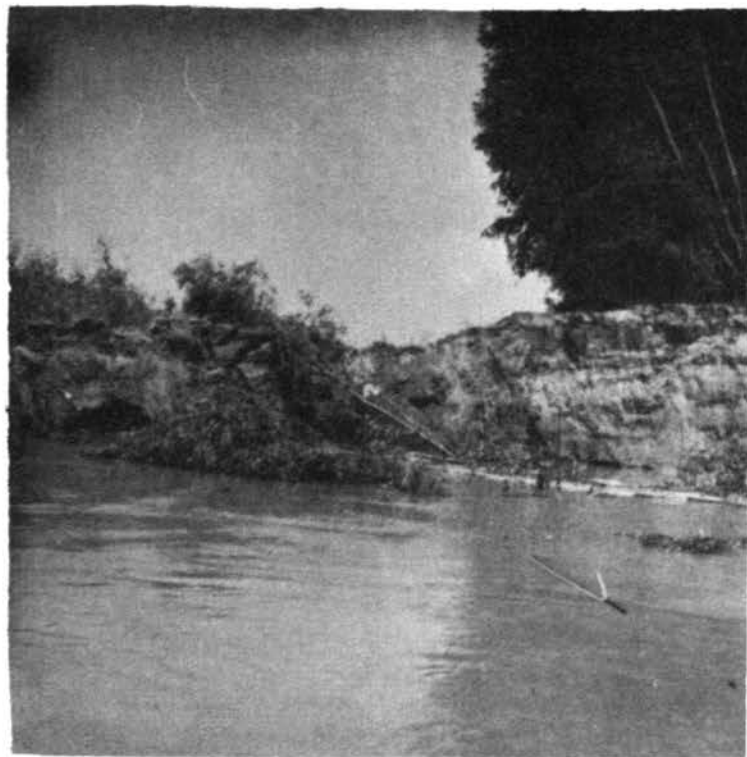
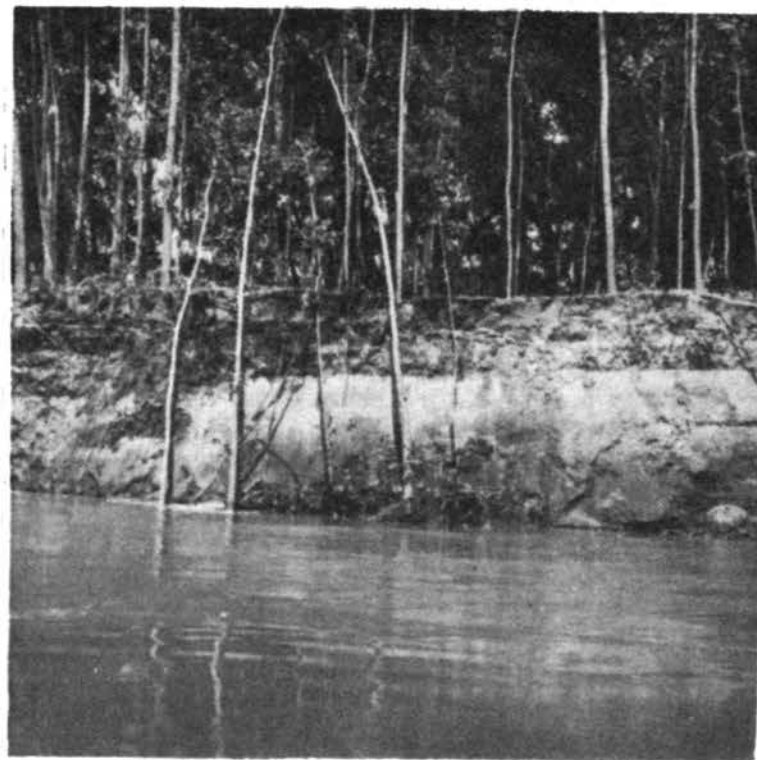
BANK CONDITIONS ON NATCHEZ ISLAND
DOWNSTREAM POINT 18 JUNE 1949

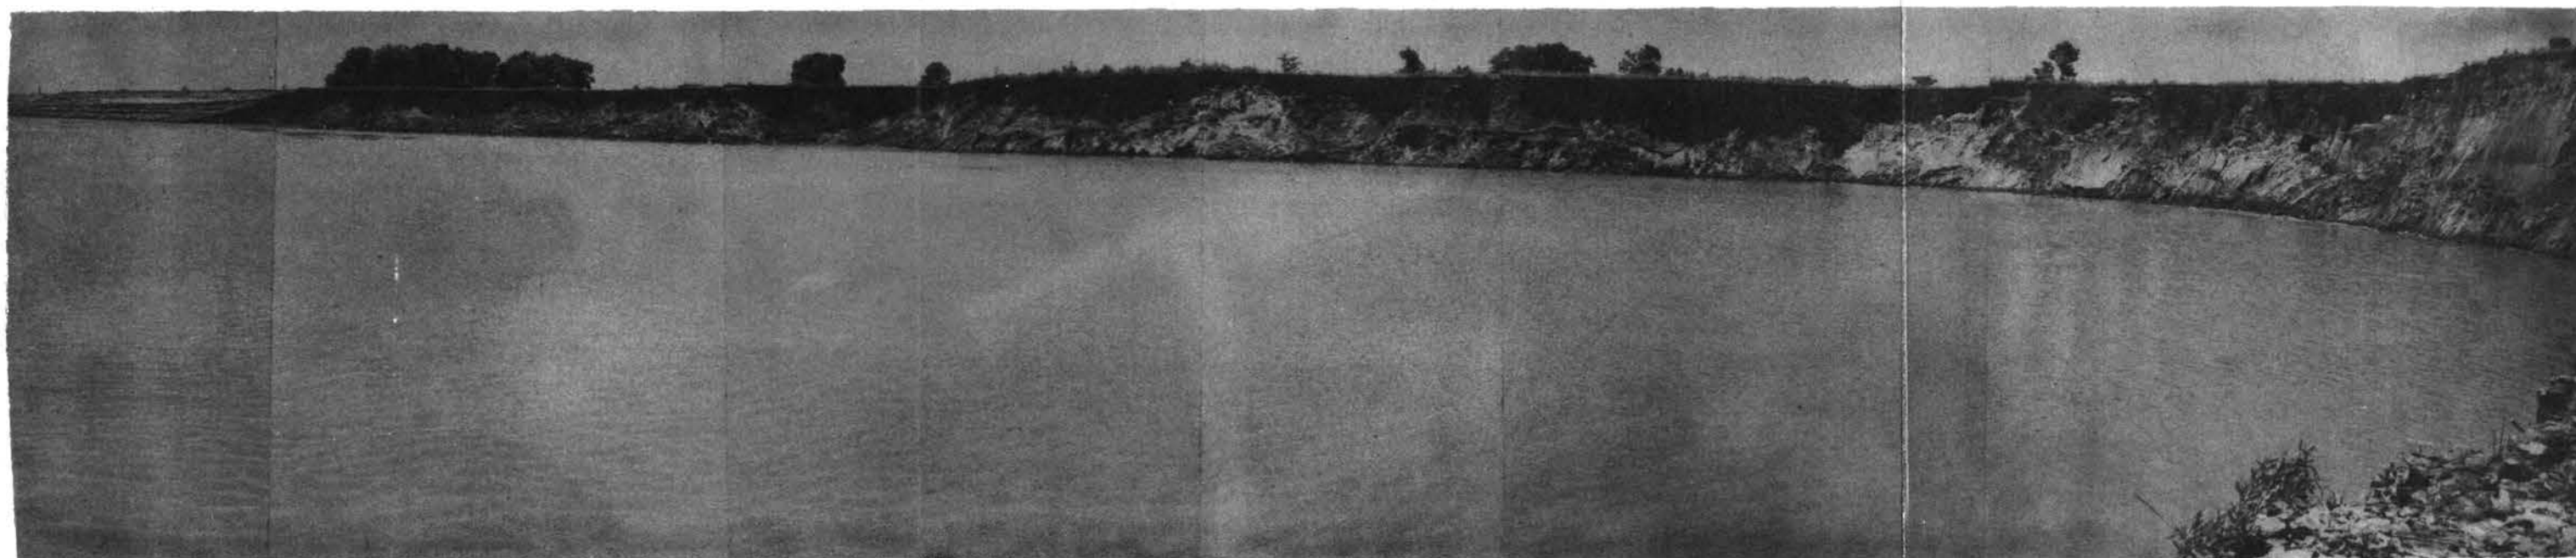
8. The failure was located at the upstream edge of the earlier failure which had occurred during construction, and may properly be considered an extension thereof. It carried away the exposed point left by the first failure, but another point remained on range 7-D and the cove was enlarged. Plate 11 is a picture of the cove, taken several days after the failure from the exposed point on range 7-D. No marked

ORIGINAL FAILURE
TAKEN FROM POINT ON RANGE 7-D—2 JUNE 1949

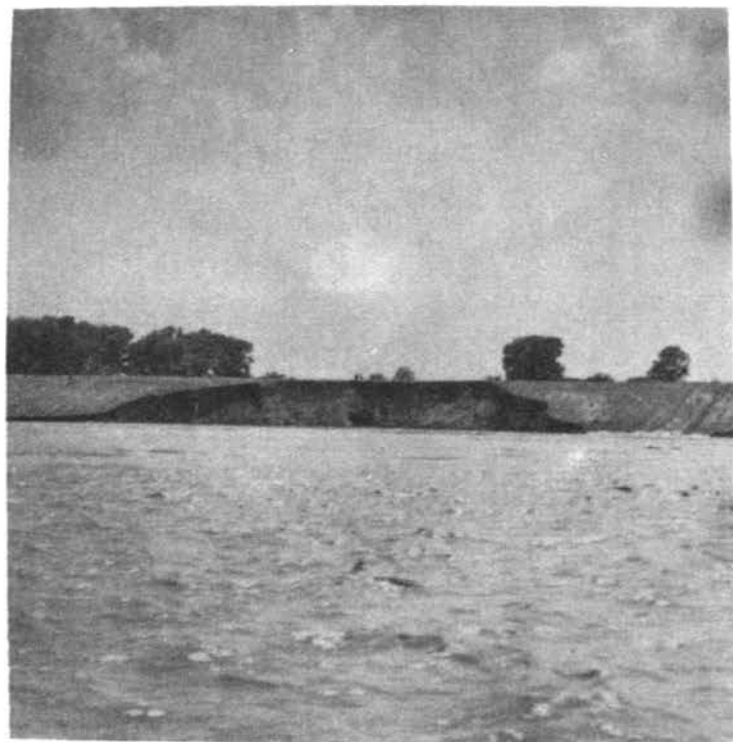
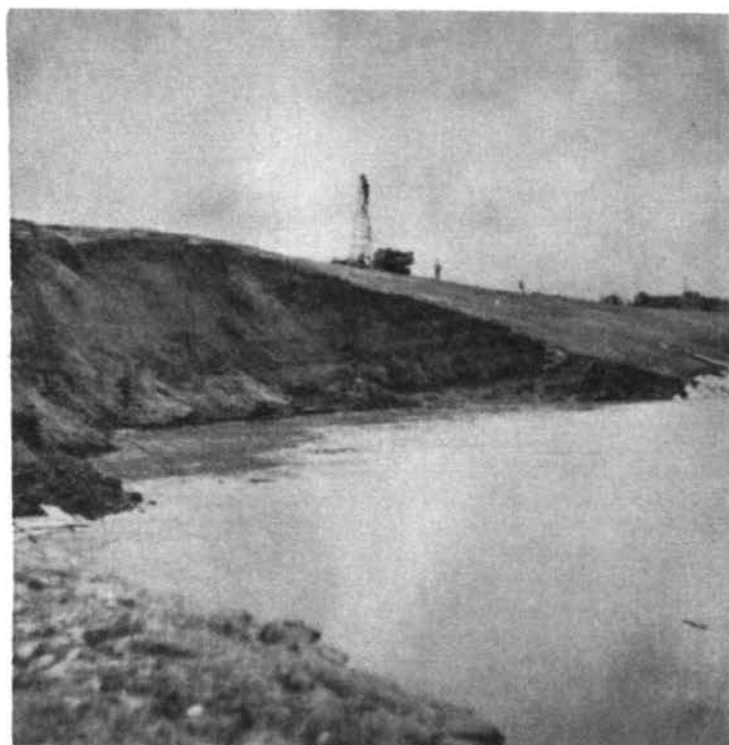
FAILURE AT RANGES 13-D—14-D

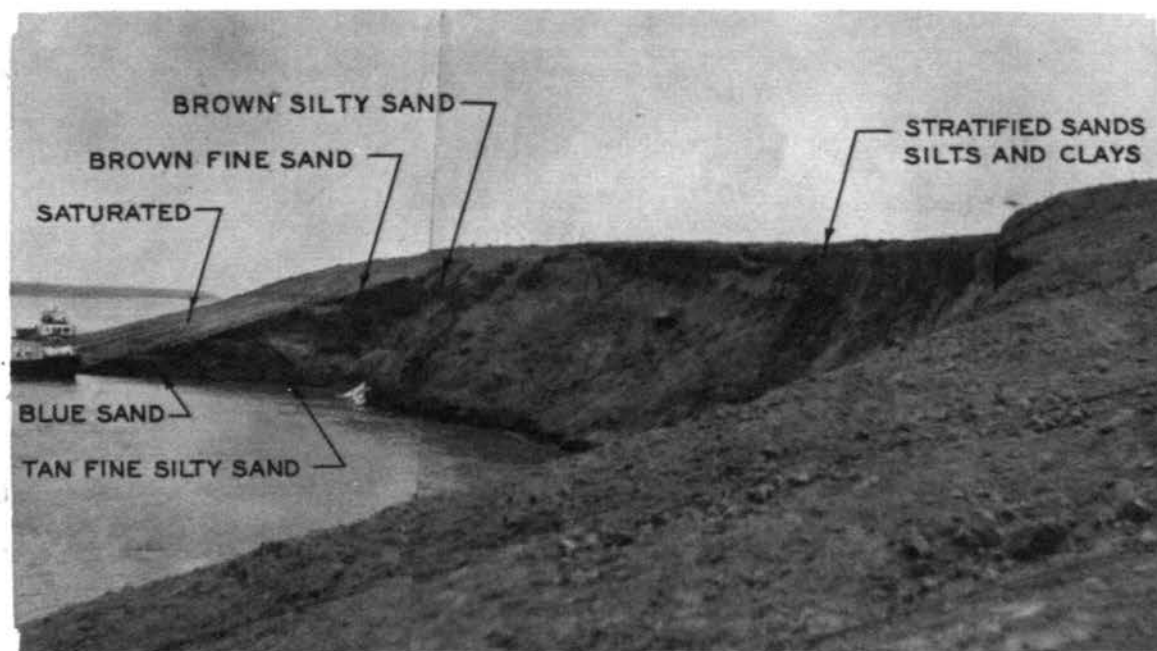
SOIL STRATA EXPOSED BY FAILURE AT RANGES 13-D — 14-D

TAKEN FROM RANGE 12-D LOOKING DOWNSTREAM

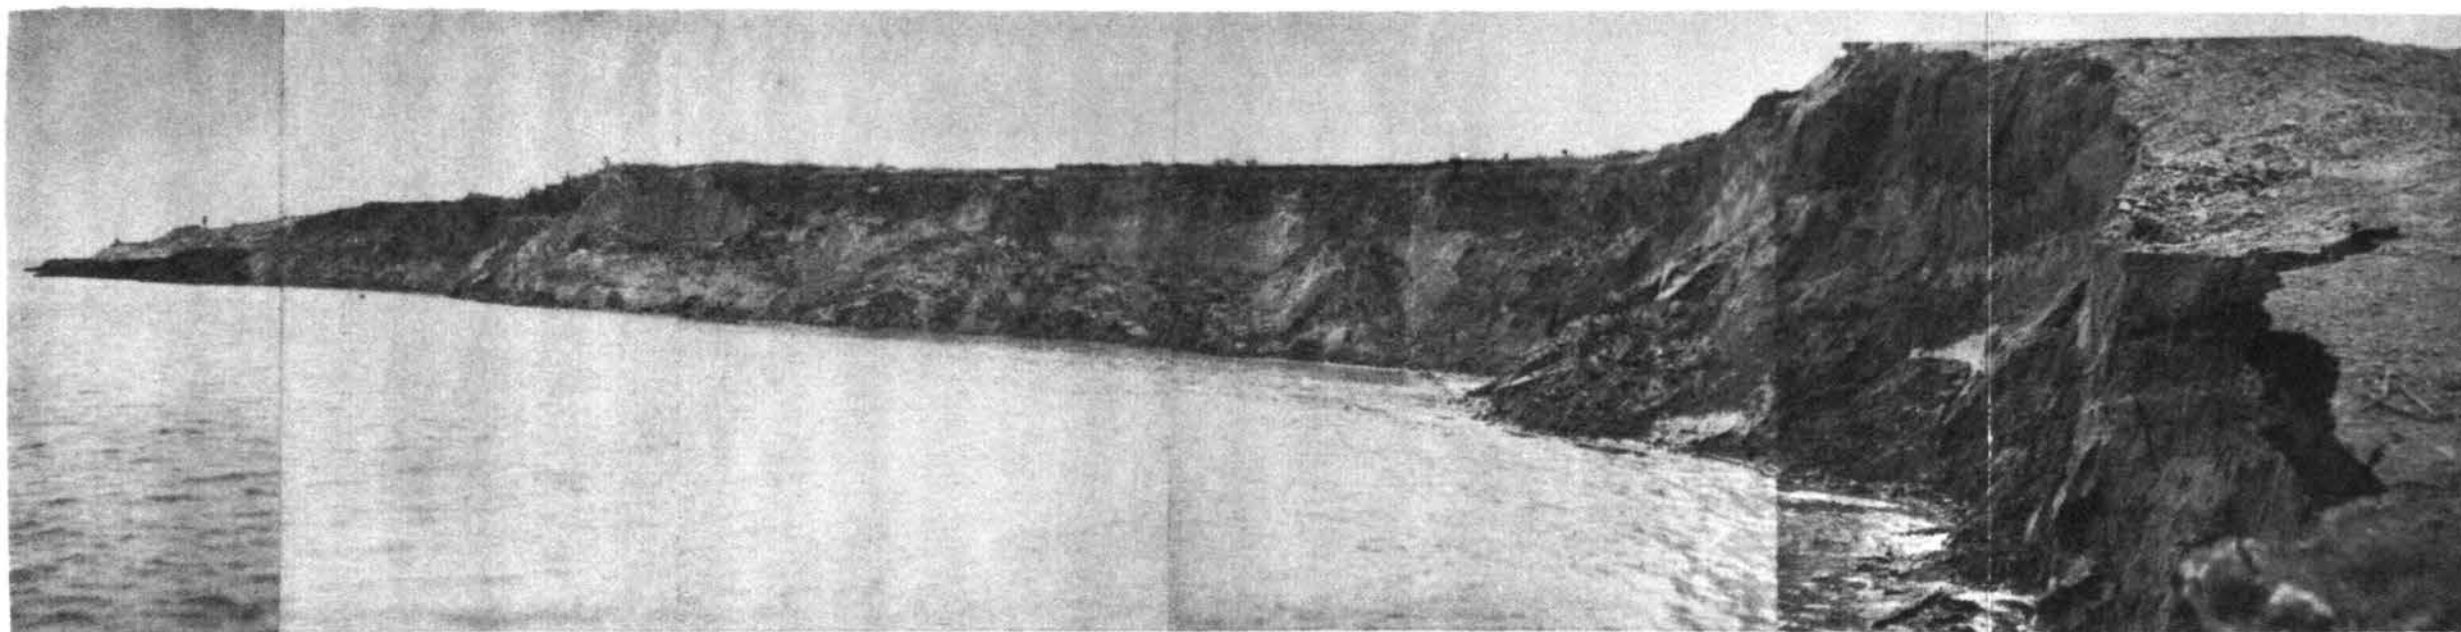
approximately 50,000 cu yd, occurred between ranges 18-D and 21-D. The soil strata exposed by this failure also appeared to slope away from the river. The general appearance of the failure is shown by plate 17.

FAILURE OF 13 JUNE 1949 AT RANGES 18-D — 21-D
TAKEN FROM RANGE 18-D — 14 JUNE 1949

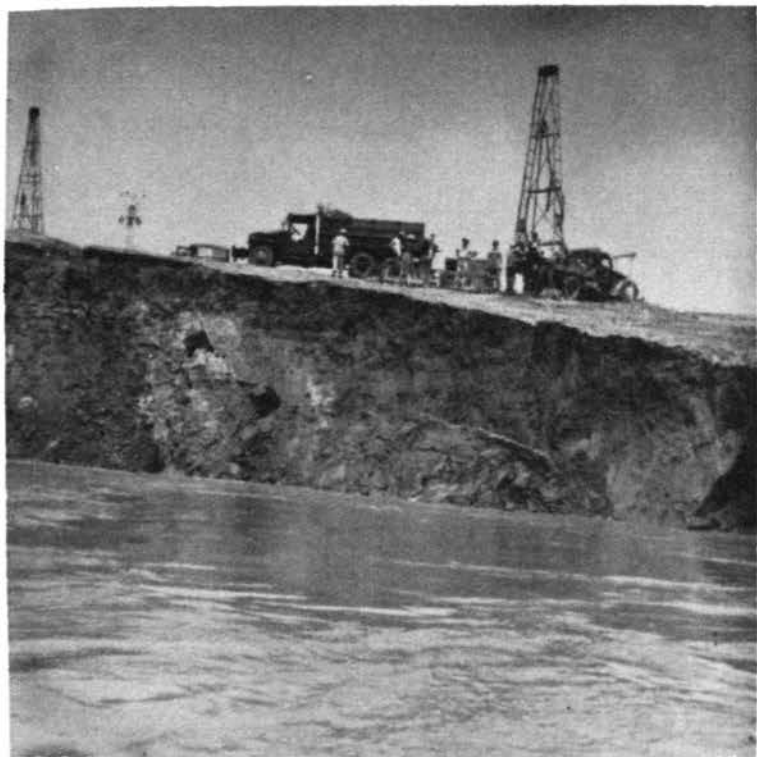
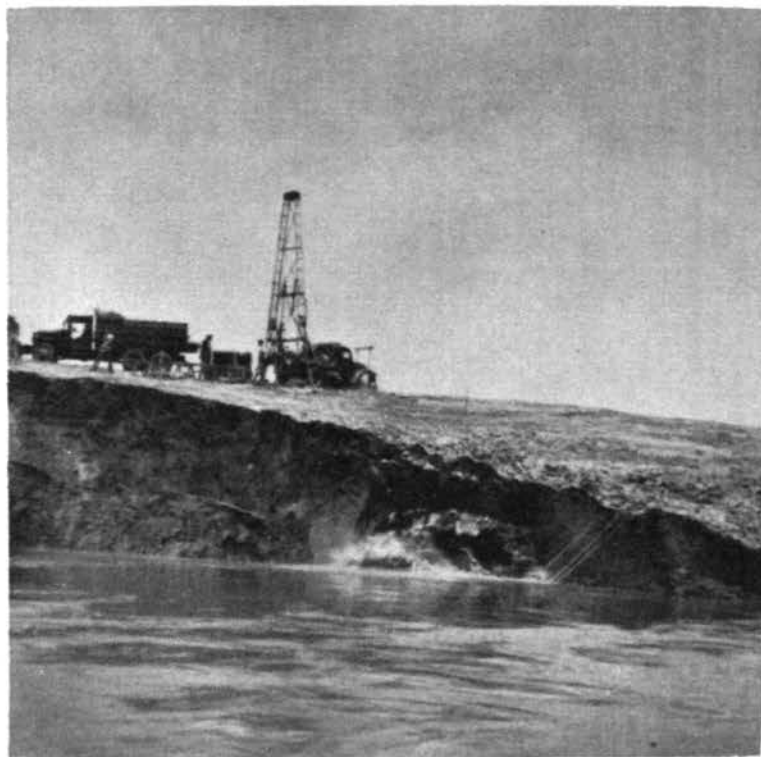
34. The initial failure area was subsequently enlarged by successive smaller failures which included the location of borings R2-2 and R2-3. Thus, the samples from these borings were from soils that were definitely involved in a failure.

BANK CAVING NEAR BORING R-2-3

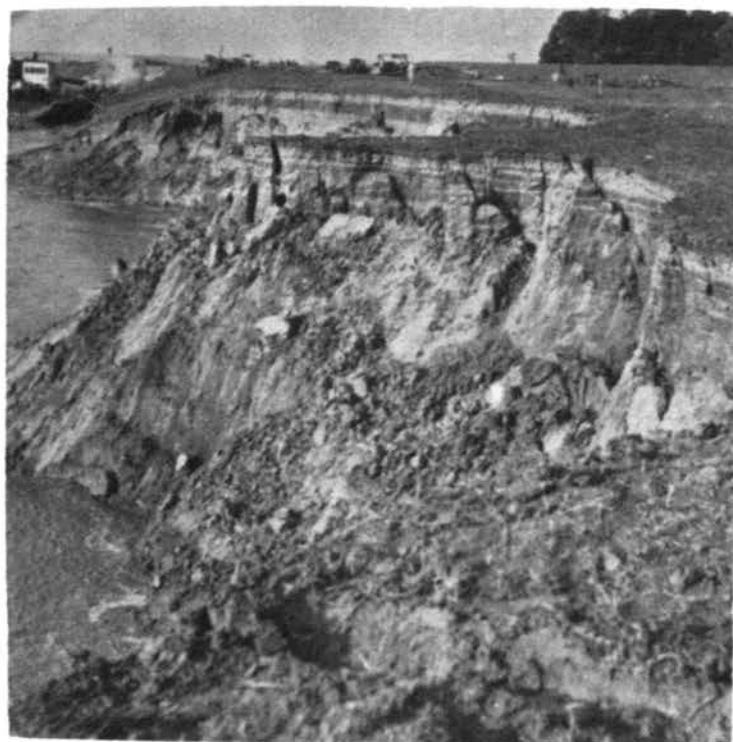
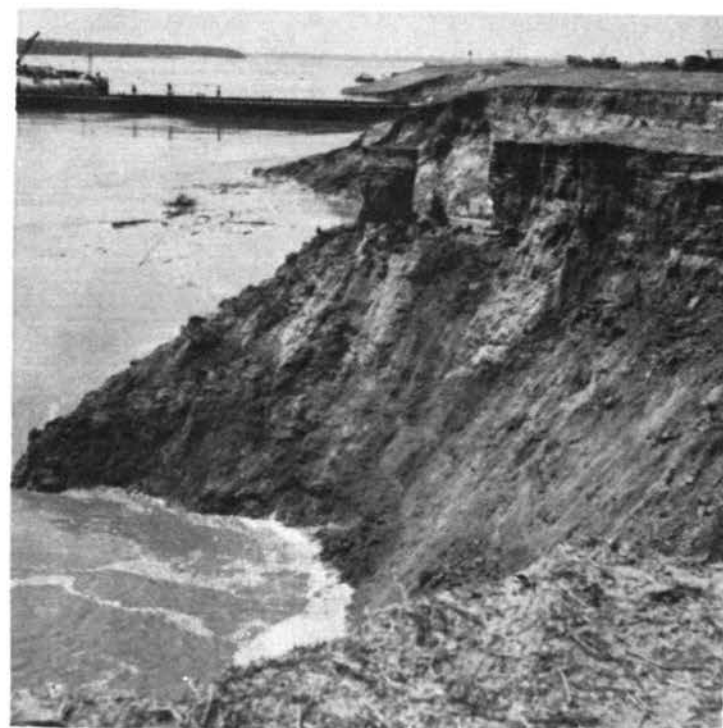
BANK CONDITIONS RANGE 2-D LOOKING DOWNSTREAM

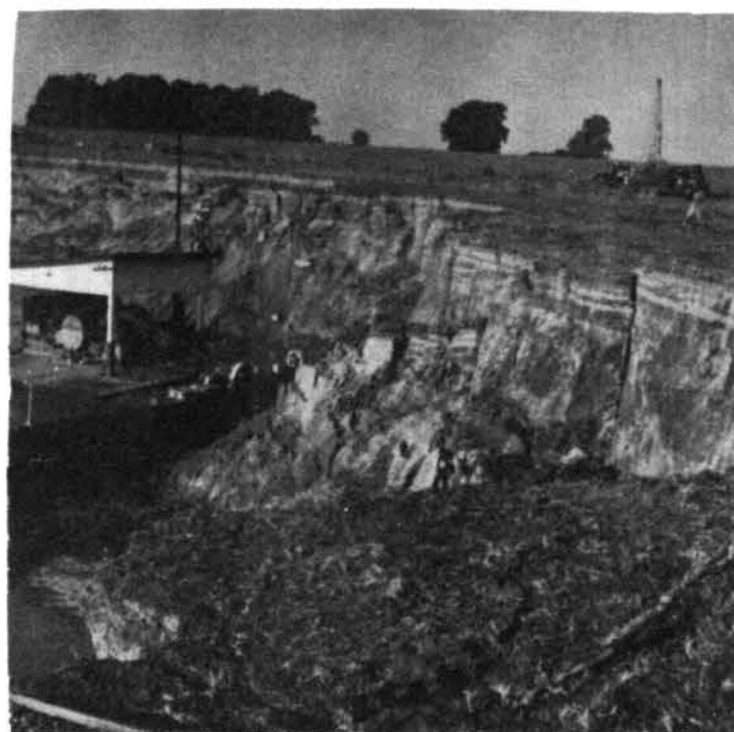
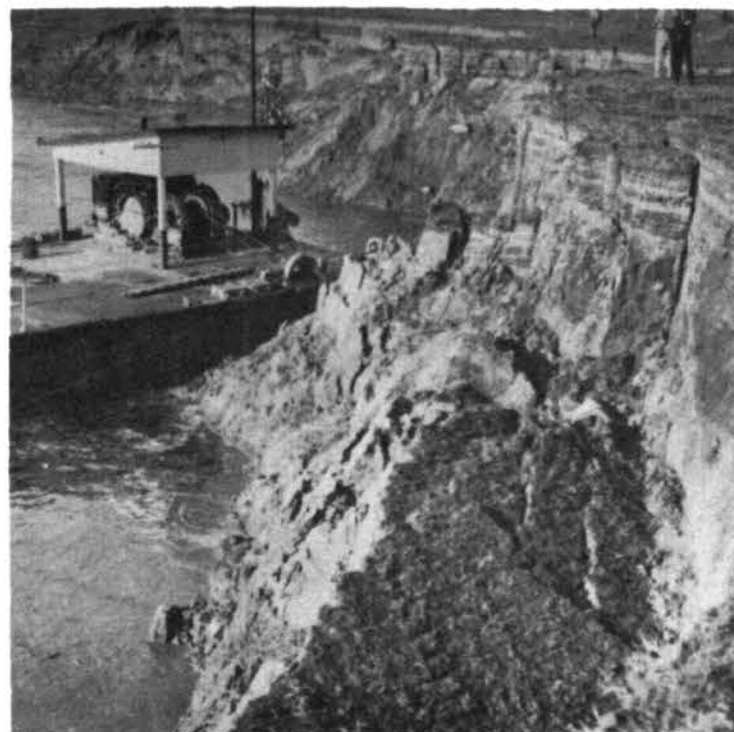
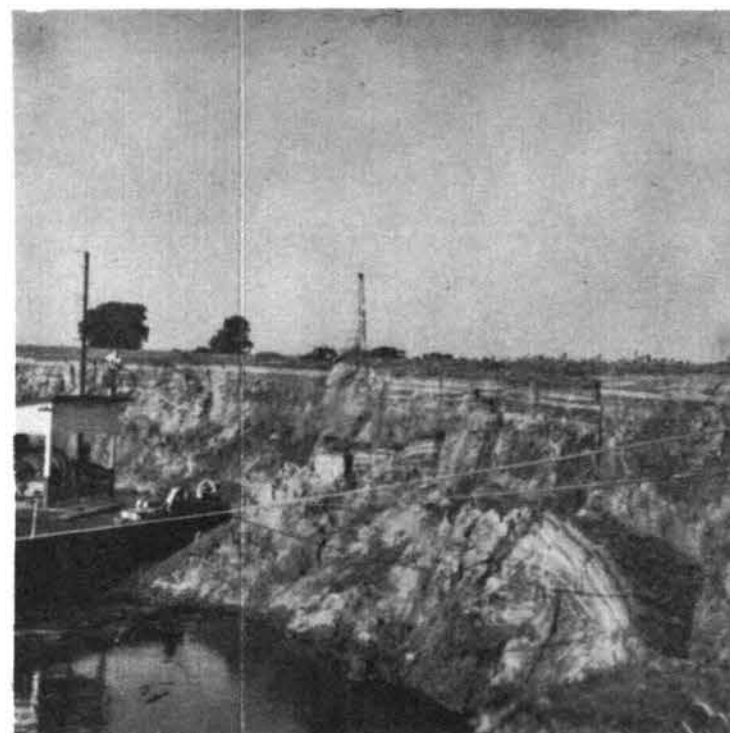
BANK CAVING AT RANGE 3-D
19 JUNE 1949

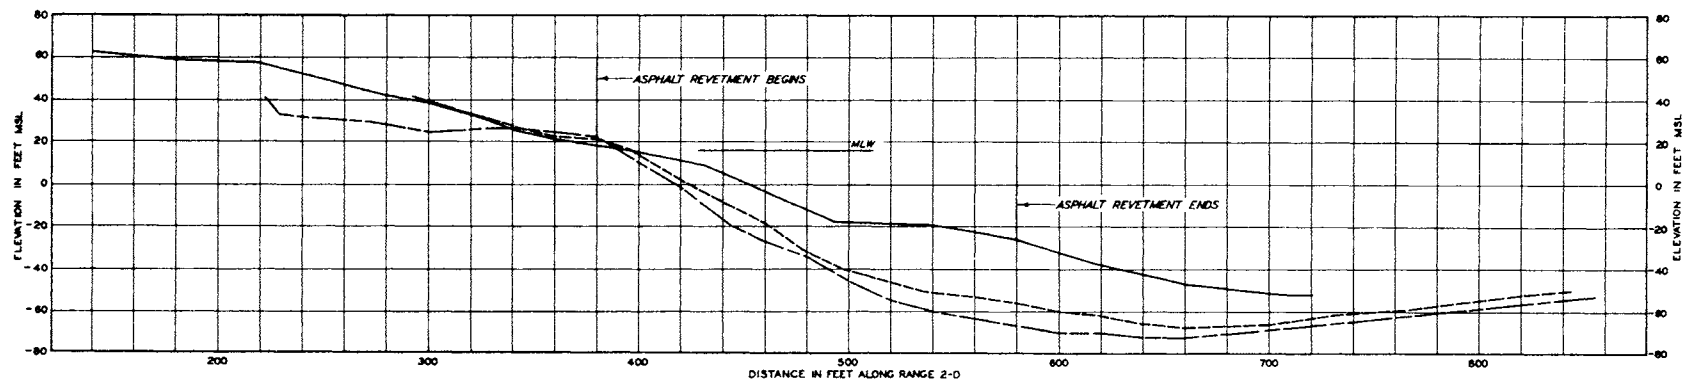
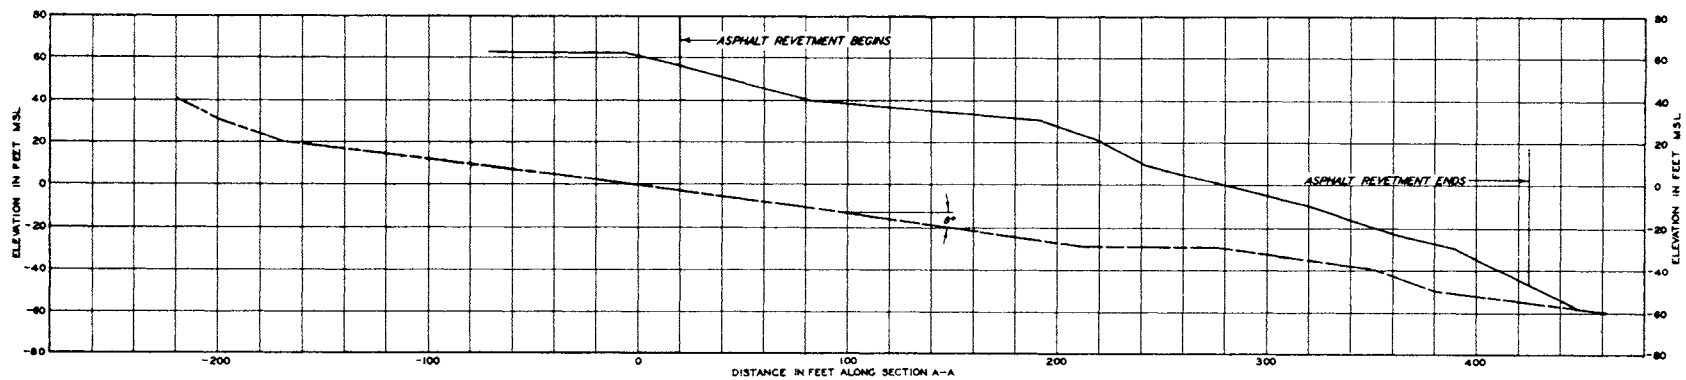
BANK PROFILES ALONG
RANGE 2-D AND SECTION A-A

The flat slopes after failure are readily apparent. The bank remained generally unchanged at range 2-D (plate 33) and range 4-D (plate 34) immediately after the first failure. The exposed point caused by the swale filling extended through range 6-D, as evidenced by the peak in the 7 June survey shown on plate 34. Section AA, shown in plan on plate 32 and in section on plate 33 most nearly corresponds to the direction of the axis of the failure. A stability analysis of this section indicates that the most critical surface corresponded to the after-failure surface. The angle of internal friction of the deep sands needed only to have been 12.7° to maintain a factor of safety of 1. The analysis of the subsequent failure of the exposed point (assuming that it failed in a direction parallel to the range lines) indicates that an angle of friction of 23.2° would be sufficient to maintain stability. The sand in the small failure at range 13-D needed an angle of internal friction of only 12.9° to maintain stability.

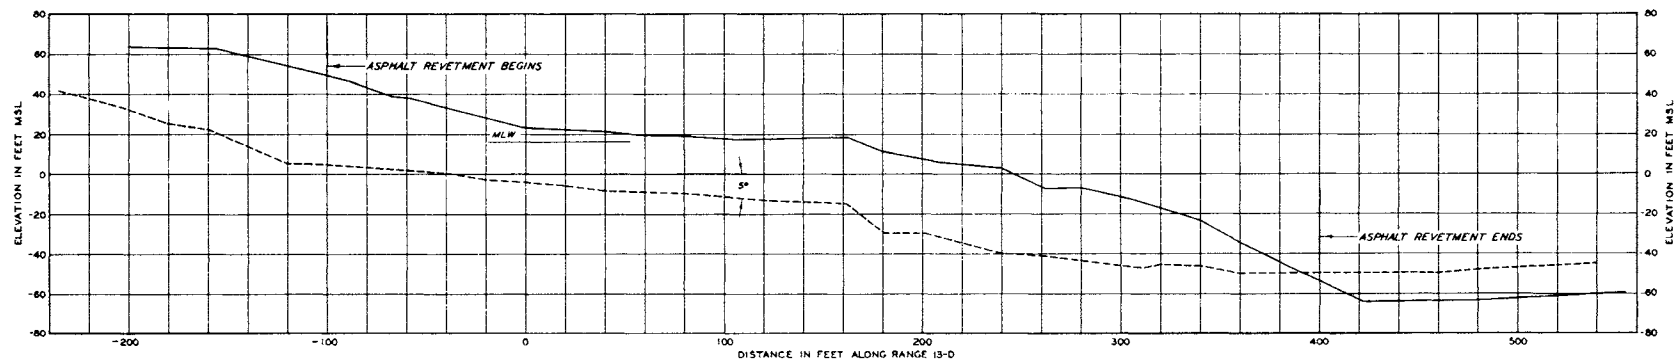
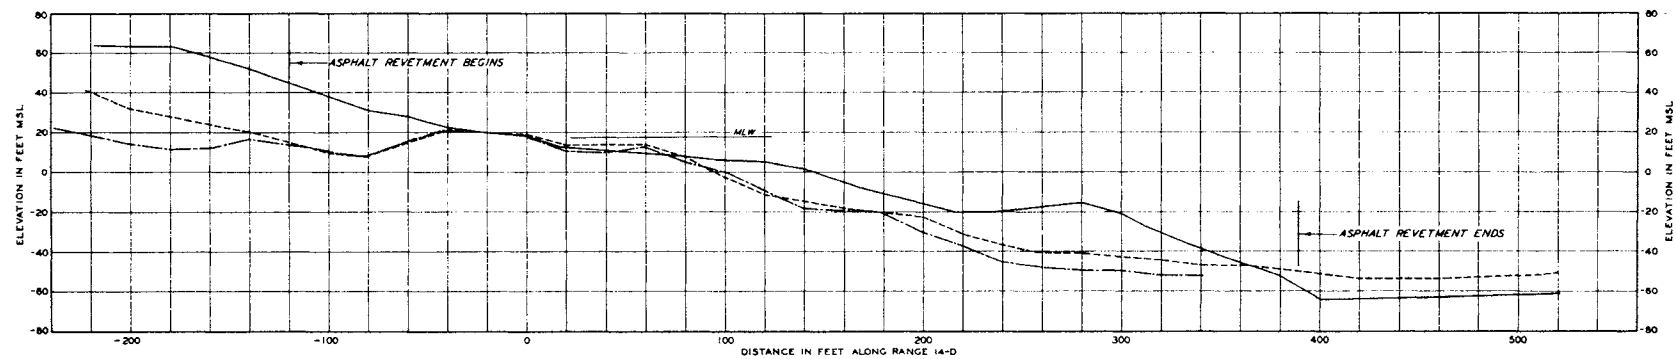
**BANK PROFILES ALONG
RANGES 13-D AND 14-D**

56. The size and shape of the failure at ranges 6-D to 16-D are shown on plate 32. Plates 33 to 35 are profiles of various sections and ranges for the before- and after-failure slopes. The profiles for the small, subsequent failure on ranges 13- and 14-D are presented on plate 36.
